APPLICATION OF REMOTE SENSING, GIS AND DIGITAL SHORELINE ANALYSIS SYSTEM (DSAS) TO ASSESS THE CHANGES OF THE RED RIVER BANK IN THE AREA FROM SON TAY TO GIA LAM (HANOI)

Nguyen Thi Nhan^{*}, Nguyen Xuan Tung, Bui Thi Bao Anh, Nguyen Xuan Thanh

Institute of Marine Geology and Geophysics, VAST, Vietnam

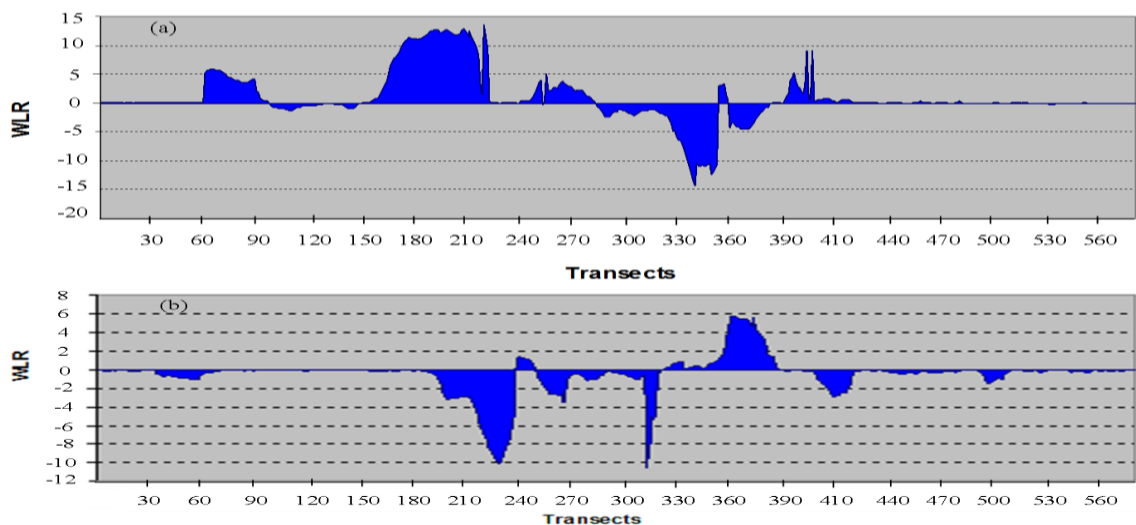
Fig. 4. Graph of erosion and accretion rate: (a) left river bank and (b) right river bank (period of 2007–2016)

Fig. 4 illustrates the fluctuation rate of the Red River shoreline in the area from Son Tay to Gia Lam (Hanoi) as follows:

In the first about 4 km, the right Red river bank was quite stable, then in the following 2 km river bank has signs of light erosion with the rate of 0.5–0.7 m/yr. Far from Son Tay about 7 km to the southeast, river bank was quite stable; in the next 5 km (belonging to Linh Chieu, Sen Chieu), river bank was eroded weakly in horizontal direction, erosion rate was 2.5–6.5 m/yr. In the Vinh Ninh area, the accretion occur mainly on the left river bank with accretion rate of 1.0–1.2 m/yr.

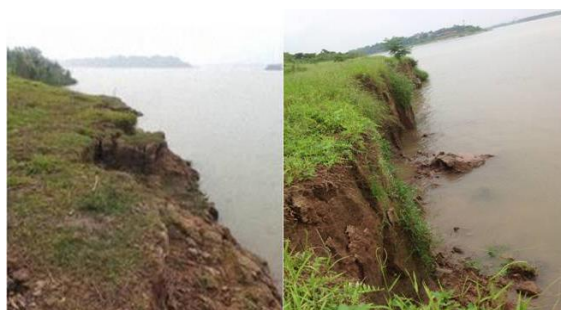
Fig. 5. Collapse slump at alluvial plain in Tam Xa, Dong Anh in 2014 and 2017

The Tam Xa alluvial flat (in Dong Anh, Hanoi) was often slumped, especially at the end

of the flat, the erosion rate was 2–3 m/yr in 2010 and increased to 4–5 m/yr in 2014 [18]. The shoreline was slumped in vertical direction with the height of 500 m. This damaged a large area of agricultural land, narrowed the area of alluvial plain and impacted on the stabilization of the levee on the right Red river bank. In the present, this area continues to be eroded strongly (fig. 5).

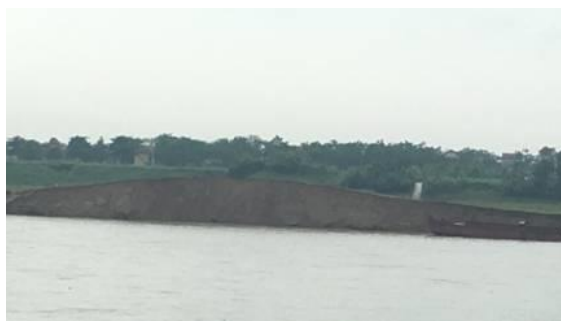
Fig. 6. Slump on the left bank of Red river in Me Linh, Hanoi

In Me Linh, the shoreline was eroded about 1,000 m in length and created a vertical surface. The erosion is extended more and more widely and causes the loss of agricultural land (fig. 6).

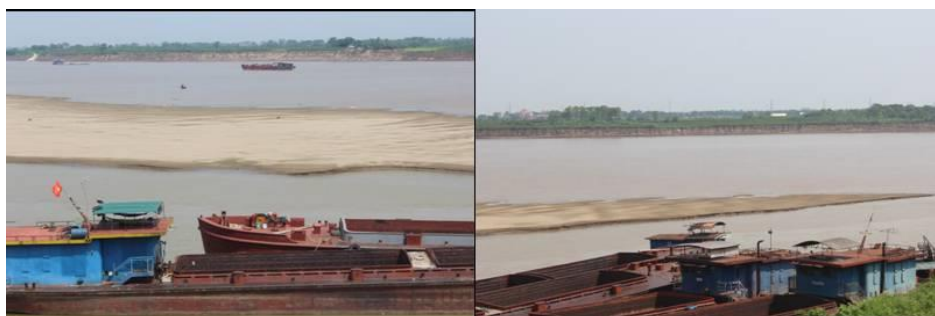
Fig. 7. Signals of erosion and accretion process in Lien Ha, Dan Phuong, Hanoi (10/2016)

The formation of alluvial plain in the middle part of the river in Lien Ha commune, Dan Phuong district, Hanoi made the total runoff flow toward the shoreline on the right Red river bank in Trang Viet commune, Me Linh district. As the result, the shoreline in this area was undercut deeply and eroded strongly (fig. 7).
