## EROSION FEATURES ALONG CUA DAI BEACH, HOI AN CITY, QUANG NAM PROVINCE, VIETNAM

**Le Dinh Mau\***, **Pham Ba Trung**, **Tran Van Binh**

*Institute of Oceanography, VAST, Vietnam*

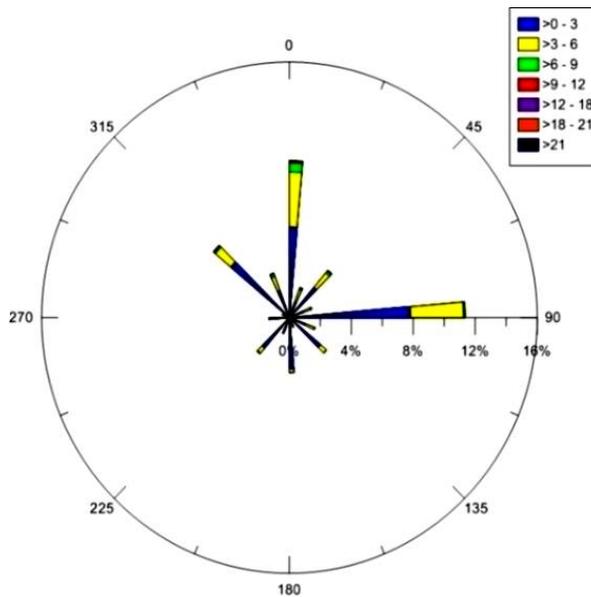
are present. At about 12 km distance from the Thu Bon river mouth in the northeast direction, Cham island of 8 km width is present (fig. 1). Coastline consists of long sandy beaches, with medium to fine sand and with median size approximately ranging from 0.15 mm to 0.2 mm. Wind rose diagram at Da Nang Station (1977–2007) shows that the main wind direction and intensity are in North (N) and East (E) directions (fig. 2).

Fig. 2. Wind rose diagram at Da Nang Station (1977–2007)

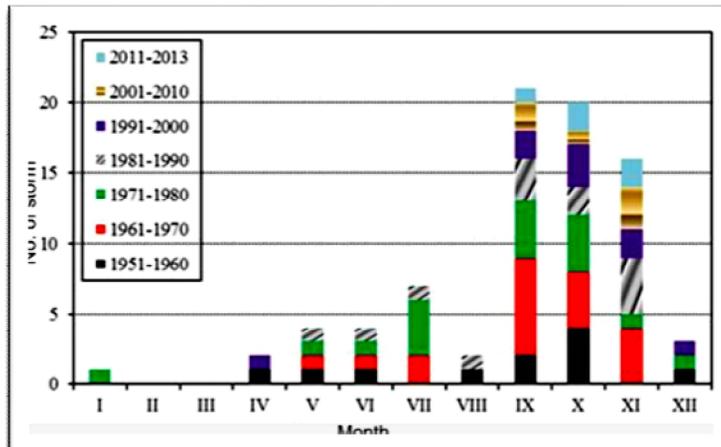
Typhoon in Hoi An waters (1951–2013) mainly occurred from September to November (fig. 3).

Fig. 3. Typhoon activity in Hoi An waters (1951–2013)

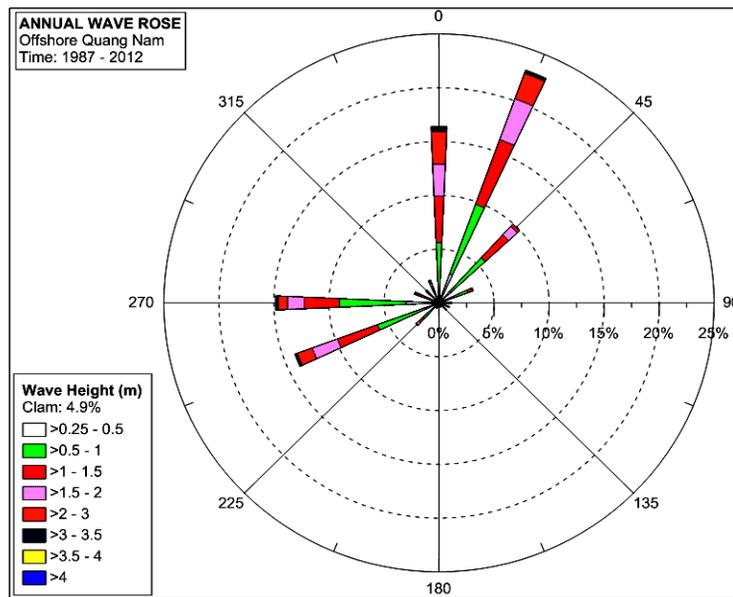
Wave rose diagram in the offshore region of Cua Dai coast during 1987–2012 (WAM model results) shows that the significant wave action comes from North (N) to North-East (NE) directions (fig. 4).

Fig. 4. Wave rose diagram in the offshore region of Hoi An coast during 1987–2012 (WAM model results)

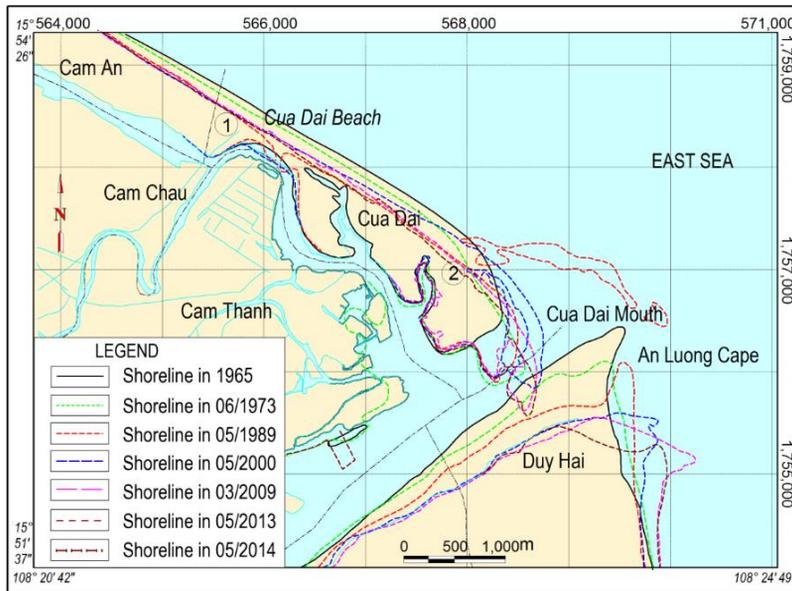
Fig. 5. Shoreline change in Cua Dai beach from 1965 to 2013

The data in table 3 and fig. 5 show that Cua Dai beach erosion/deposition phenomenon occurred a long time ago but the rate of accretion was larger than that of erosion. From the year of 2000 to present the rate of erosion

was larger than that of accretion. In the period from the year 2000 to present along Cua Dai beach a lot of beach resorts have been constructed which caused the beach erosion more intensely (fig. 6a, 6b).

**Features of Cua Dai beach erosion.** Cua Dai beach erosion features in different periods (1965–2013) are shown in table 3, fig. 5.

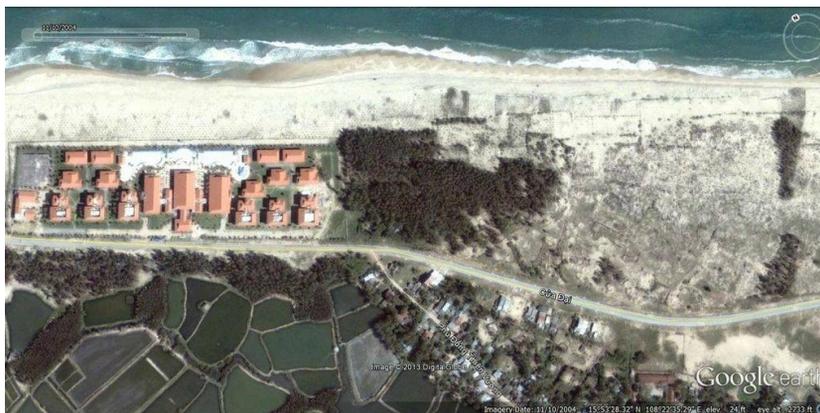
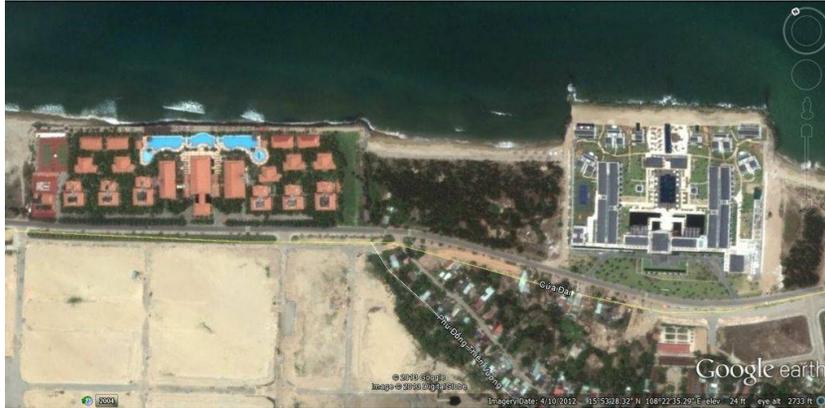
Fig. 6a. The shoreline at Sunrise Resort on 11/10/2004

*Fig. 6b. The shoreline at Sunrise Resort on 4/10/2012*

The beach in front of Sunrise Resort was destroyed in 2012, in 2004 beach was broad at about 100 m from the road. Features of beach

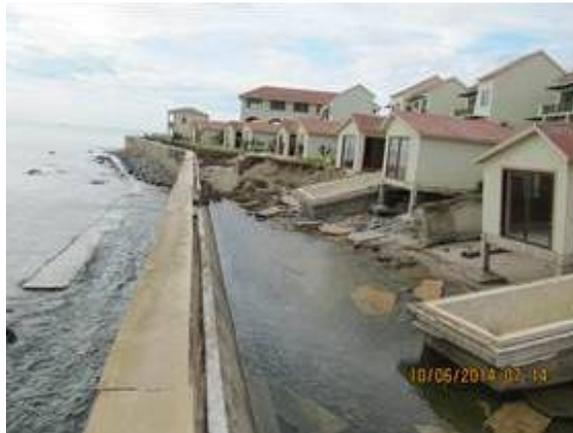
*Fig. 7a. Beach resort properties destroyed in Cua Dai (10/5/2014)*

The above-mentioned data show that the causes of beach erosion are very complicated. The shore protection structure and resort properties were destroyed mainly from wave action by “under-tow” mechanism (fig. 7a). These data show that the Cua Dai beach was seriously eroded and at present the intensity of beach erosion is more serious.

erosion in Cua Dai (2013–2015) are shown in fig. 7a, 7b.

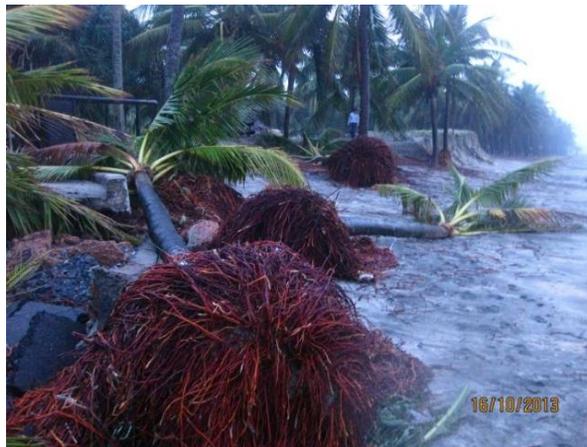
*Fig. 7b. Cua Dai beach erosion (16/10/2013)*

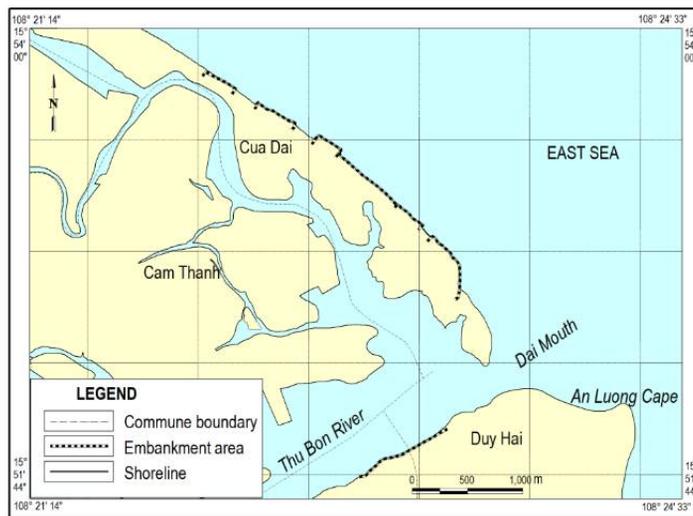
to Cua Dai, consequently the coast is eroded. And one more similar problem is that in downstream area of Thu Bon river the sand mining activity is not controlled. At present, most of the eroded beaches in Cua Dai have been protected by hard structures such as revetment, sea wall... (fig. 8a). These hard protection structures were constructed by local government and resorts without uniformity in design (fig. 8b, 8c, 8d). Therefore, they made the increase of wave intensity and blocking of longshore sediment transport which was supplied from Thu Bon river mouth.

Fig. 8a. Location of hard protection structures along Cua Dai beach

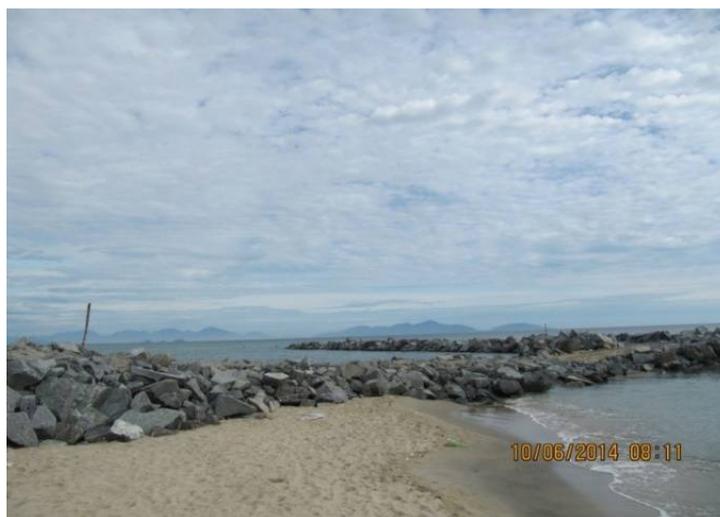
Fig. 8b. Groin to protect the resorts in Cua Dai (10/6/2014)

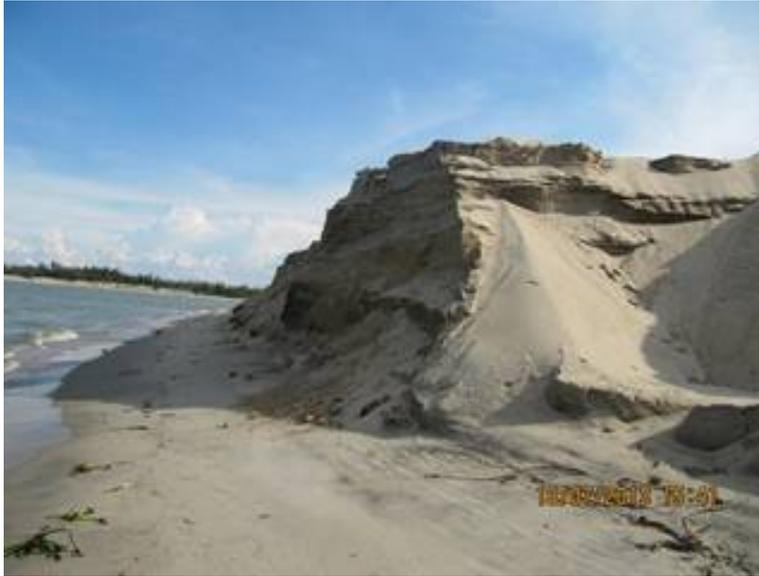
*Fig. 8c. Dredging sand from Thu Bon river mouth (7/2013)*

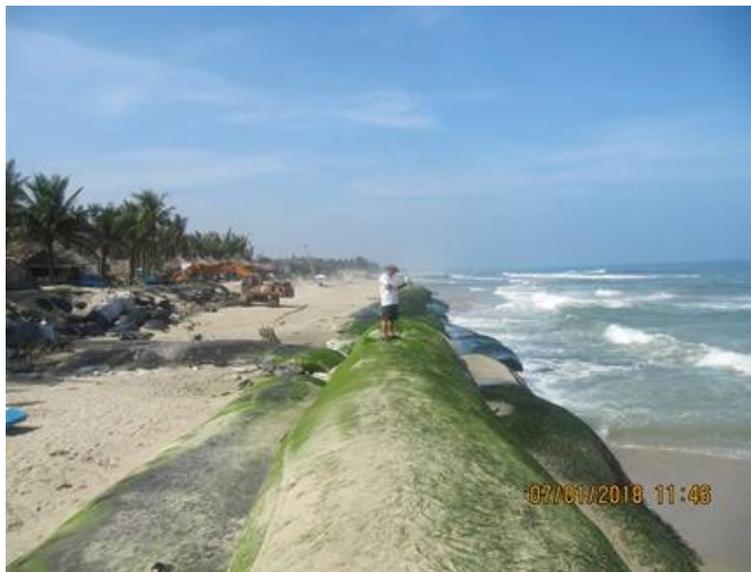
*Fig. 8d. “Soft structure” to protect Cua Dai beach (7/1/2018)*
