The solutions for construction of sea dike and sea embankments system as the sandy mud trap to support mangrove plants in the coastal zone of Hai Phong city, Vietnam

Vu Doan Thai*, Thai Van Nam

HUTECH Institute of Applied Sciences, Ho Chi Minh city, Vietnam

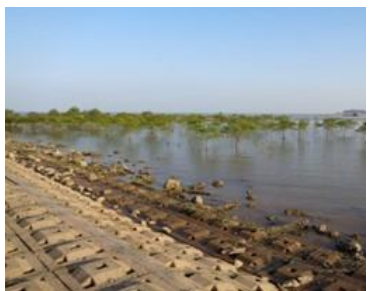
Figure 3. Groins and tree grew in the study area in 2017–2018

Next step of repair, bamboo stakes were driven into many lines and rows but had to be parallel to dyke and straight fence to join two ends of groins A & B at the seaside. Until the end of 2018, it needed to consolidate many lines of bamboo stakes to encroach outside of groins (figure 3).

Trees grew in some sites near two right sides of groins in 2018

Consolidate by bamboo stakes at sea from the middle of 2015 to the end of 2018 for sediment trapping.

* Structure of forest in the area without erosion near groins B and forest at left and right close to a body of groins B. Time of data

collection: 16 h 30' on 18th December 2018 (figure 3).

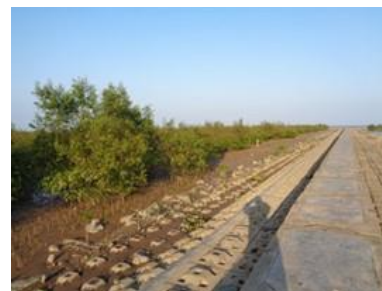
Trees grew near to two left sides of groins in 2018

At the left side of groins B near the foot of the national dyke, (*Sonneratia caselaris* (L.) Engl) was 4–4.5 m high. Out of 40 m along the body from the dam to the end of groins (*Sonneratia caselaris* (L.) Engl) was about 1.5–2.4 m high. Many breath roots, about under 100 roots/m² around the foot, there was no regenerated tree layer, only sparsely the number of trees (*Kandelia obovata* Shuen, Lui & Young) closed to the foot of groins. The covering level near the body of groins was 65%, with the length was no longer than 60 m.

Mangrove forest at the left side of groin A was more than 50 m long; and the tree was 6–6.5 m high. The rate of covering took about 40%, level of covering reached 60%. Far the foot of dyke toward end of groins, trees were 2–2.7m high, rate of covering was 60–63%, took 20% of the surrounding area. At the left side of groin B, there were regenerated (*Kandelia obovata* Shuen, Lui & Young) interposed with modest height.

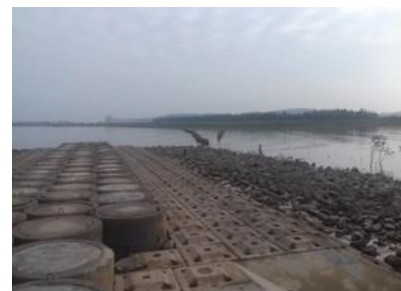
Bamboo stakes drove in sites of two groins in 2018

Table of sediment analysis at the same area. Strengthened to treat sediment trapping by rows of bamboo stakes drove parallel to shore, both inside and outside of groins at the seaside.
