## EVALUATION OF COASTLINE DEVELOPMENT OVER PERIODS IN CUA VIET AREA BY APPLICATION OF REMOTE SENSING TECHNIQUE AND GEOGRAPHIC INFORMATION SYSTEM (GIS)

Institute of Geography-VAST

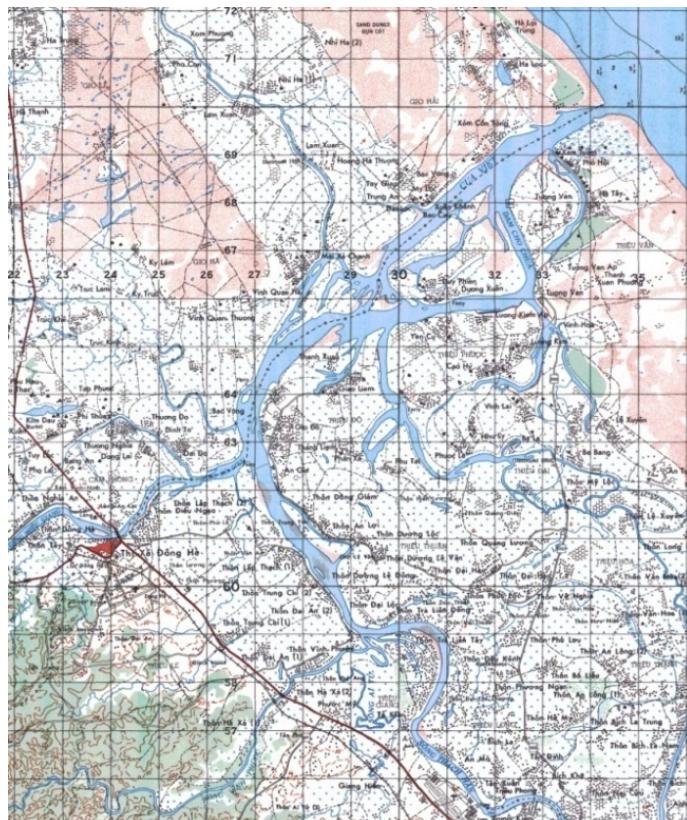
**Fig. 1.** UTM topographic map of the studied area published in 1965

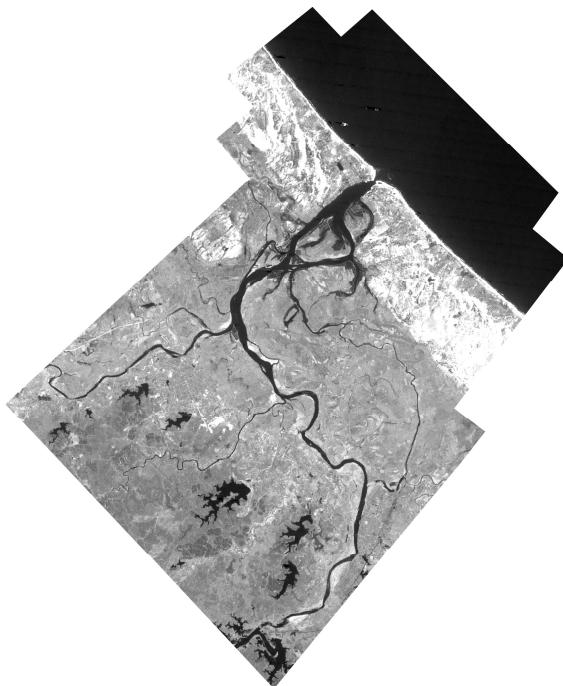
**Fig. 2.** Air photos of the studied area taken in May 1979

Black and white air photos taken in 1979 (fig.2): Provided by the Land Administration Center of Information and Archive. The original photos are of 1:10,000 scale.

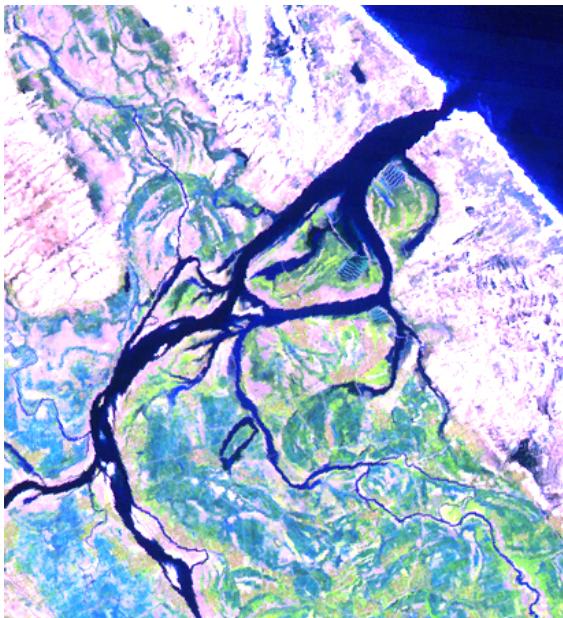
**Fig. 3.** Landsat TM satellite image of the studied area taken on 14 January 1990

LANDSAT 5 TM satellite images, consisting of 7 bands, taken on 14 June 1990 (fig. 3).

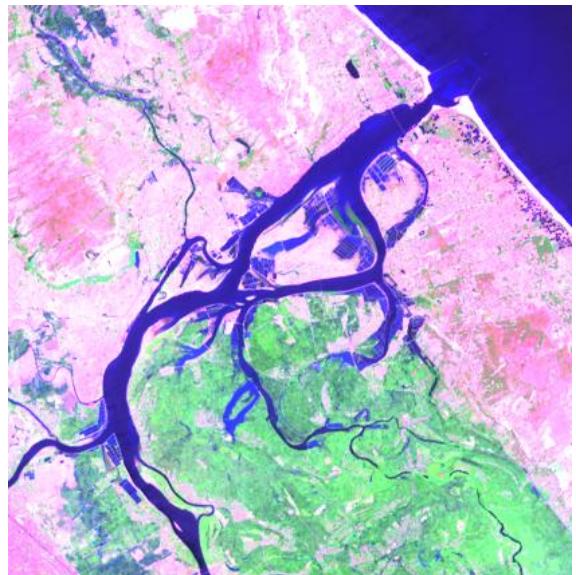
**Fig. 4.** Landsat 8 LGN satellite images, consisting of 11 bands, taken on 3 July 2015

LANDSAT 8 LGN satellite images, consisting of 11 bands, taken on 3 July 2015 (fig. 4).

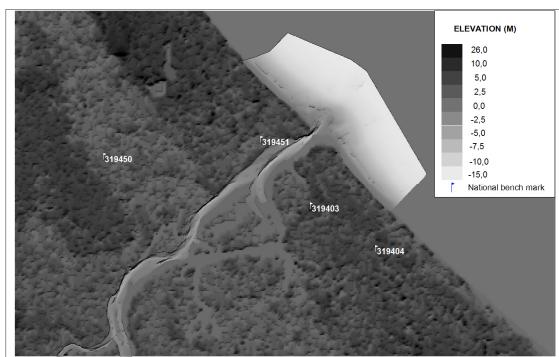
**Fig. 5.** Digital Elevation Model of studied area

After estimating tidal height, we use Digital Elevation Model extracted from global ASTER (<http://www.jspacesystems.or.jp/ersdac/GDEM/E/4.html>), national height mark and topographic maps of studied area at 1:10,000 scale which were established by Institute of Geography - Vietnam Academy of Science of Technology in 2006 and 2007, to delineate the coastline from satellite image.

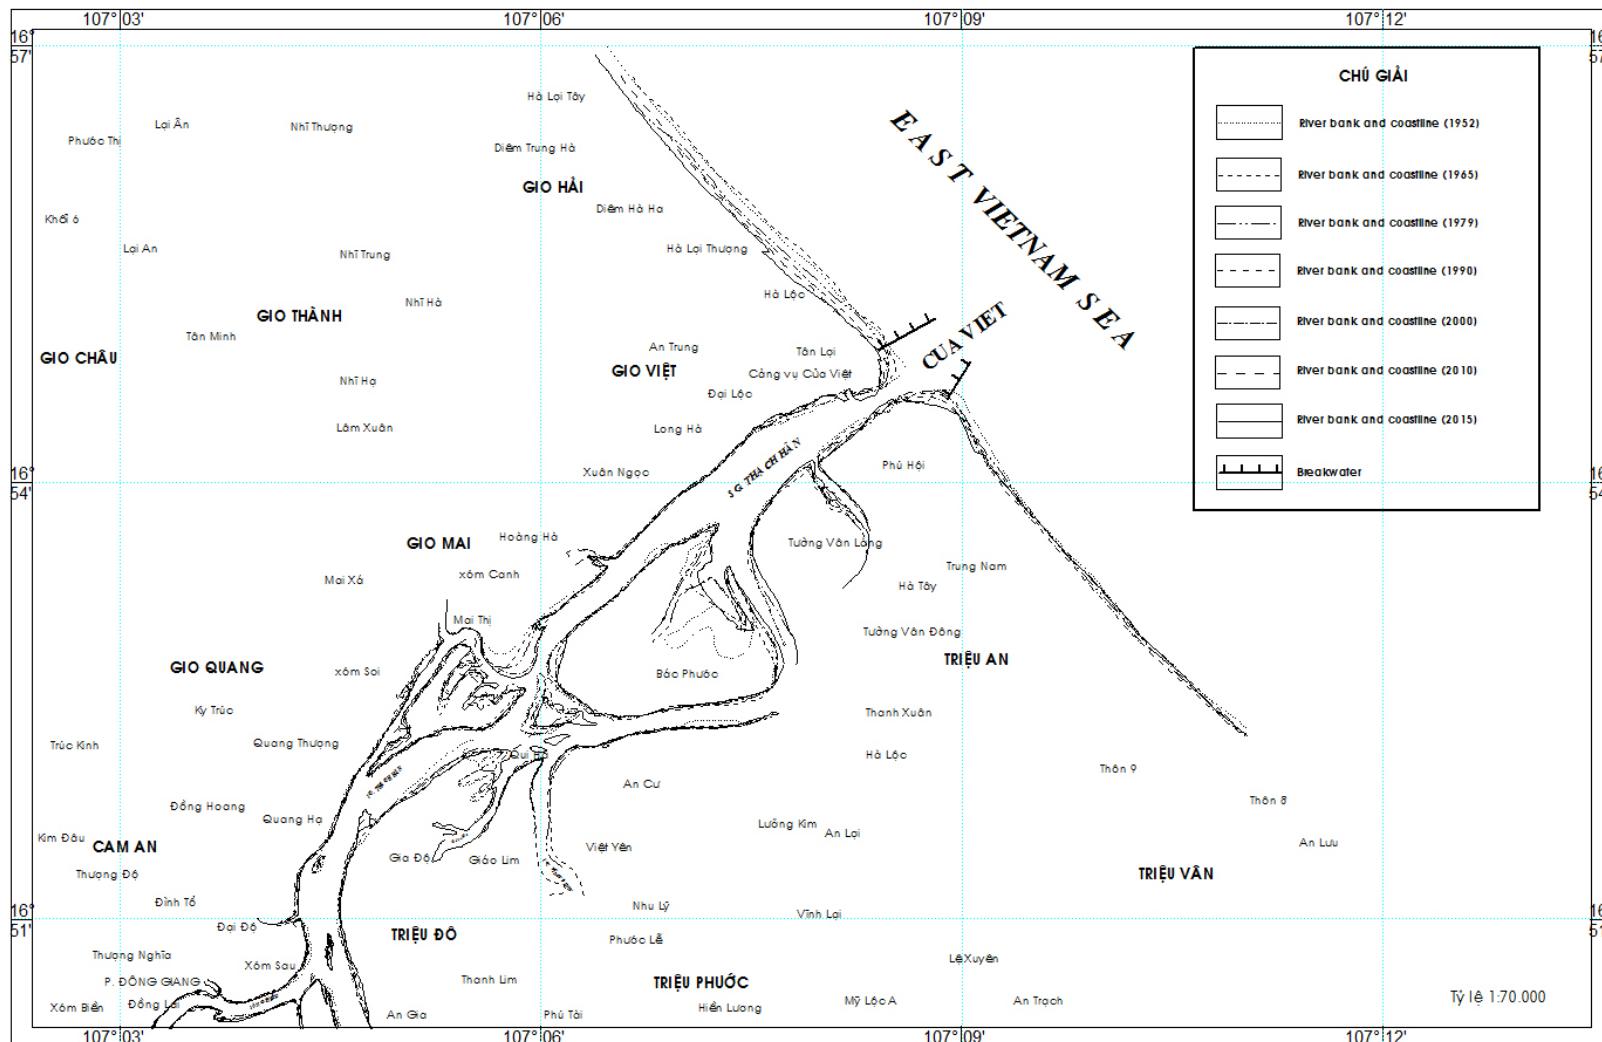
**Fig. 6.** Map of coastline changes in Cua Viet outlet area in the period 1952 - 2015

photos, satellite images and the results of survey by the Institute of Geography from 2002 to 2008 [6] the authors of this paper have a map of coastline development of Cua Viet outlet area in the period 1952 - 2015 (fig. 6). Analysis of the status of river bank and coastline over various periods in 1952, 1965, 1979, 1990, 2000, 2010 and 2015 and related data has allowed setting forth some important remarks on the coastline development in Cua Viet outlet area.

Similar to many other estuarine areas in the Central region, in the Cua Viet coastal area, there are sand dunes parallel with the coastline. The river system has divided its estuarine area into several large flood plains such as those in Gia Do, Qui Ha, Tuong Van, Mai Thi communes and many low flood plains developed in the form of "drifting sand islands" in the river channel [7] (fig. 6).

at Phu Hoi, erosion has been occurring frequently over many years but with a low intensity. The further inland, the stronger the erosion of the Thach Han river bank. Most of the bank here is protected by embankment, but erosion still occurs, affecting the production as well as the life of the local people; typically, in October 2013, storms number 10 and 11 broke the northern part of Cua Viet seawall, 3.5 km of the seawall from Gio Viet to Cua Viet was severely destroyed (see fig. 6 and tab. 1).

Recently, thanks to the completion of Hung Vuong bridge and Cua Viet seawall on both sides of the river mouth, the process of coastal erosion tends to reduce, and the seawall has started to consolidate (fig. 6 and tab. 2).
