# MECHANISM OF BEACH EROSION AT THE WEST OF PHU QUOC ISLAND, SOUTHERN VIETNAM

HUYNH TRUNG TIN<sup>1</sup>, LE HOAI NAM<sup>2</sup>, BUI TRONG VINH<sup>1</sup>

<sup>1</sup>Faculty of Geology & Petroleum Engineering - HCMUT

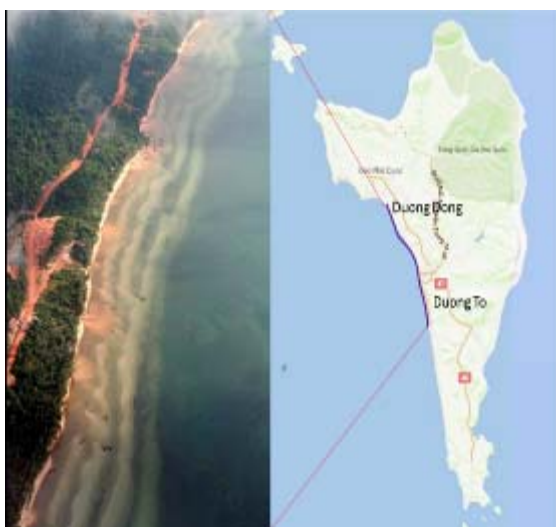
Figure 1. Study area

Phu Quoc Island locates in Gulf of Thailand, Southern Vietnam. Several years ago, due to the effect of climate change and the development of beach tourism, beach erosion in the Western beach occurred seriously. Beach erosion has both damaged the coastal resident's houses and affected to the socioeconomic in the area. Therefore, it is necessary to study about the cause to beach erosion, which can propose the mitigation method, ensure the stable development for the island. Study area is framed from Cua Can to Duong To beach, see Fig. 1 [7].

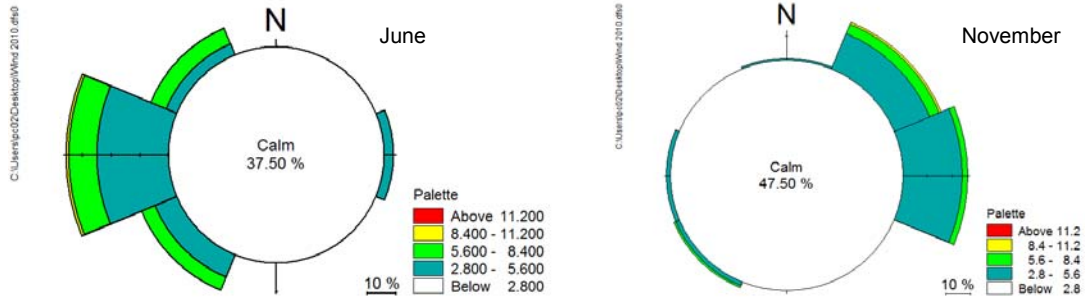
Figure 2. Predominant winds at Phu Quoc island

Western beach faces to the Gulf of Thailand, is called the “gateway” of the monsoon. The Southwest monsoon season is dominant. In history, maximum wind velocity gets 31 m/s [1]. Fig. 2 characterises the predominant winds at the Phu Quoc island in June and November 2010 [1].

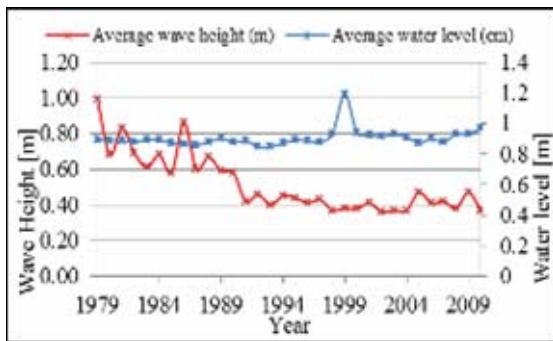
Figure 3. Annual wave height and mean water level at Phu Quoc station from 1979 to 2010

In the southwest monsoon season, wave height is higher than those in the Northeast monsoon season. Maximum wave height in the summer measured is 2 m. Average wave height is around 0.6 - 1m. In the winter (NE monsoon season), maximum wave height measured is about 1.0 m. Average wave height appears is 0.5 m. Fig. 3 presents the average wave height and mean water level at Phu Quoc station from 1979 to 2010 [1].

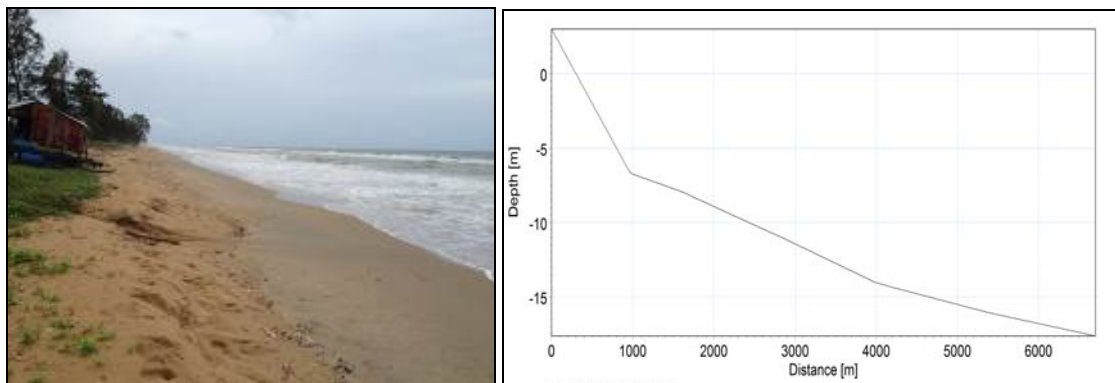
Figure 4. Beach erosion and typical section at Duong To beach

On the other hand, at the Duong Dong beach, the beach is steeper (Fig. 4, 5). The slope of beach calculated is around 1:118. The steep beach is one of the main causes to beach erosion in this area.

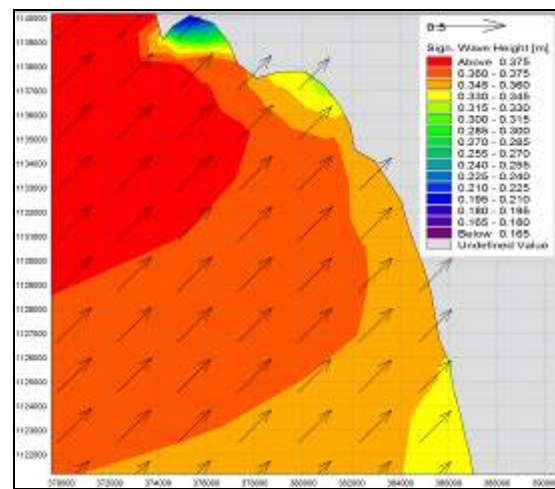
Figure 6. Wave distribution in the summer

*Fig. 6* presents the wave distribution in the summer. Result shows that, significant wave height is around 0.6 - 1 m. Wave-induced in the summer varies from 0.4 to 0.6 m/s. Long-shore current brings the sediment material from South to North (*Fig. 7*).

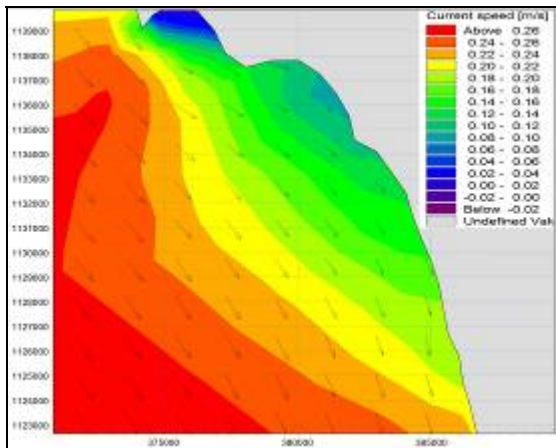
Figure 8. Current in the NE monsoon season

In the winter (NE monsoon season), wave height is about 0.5 m, current flows from North to South. Maximum current speed is about 0.5 m/s. *Fig. 8* and *Fig. 9* present the simulation result of wave induced and wave distribution in the NE monsoon season. In this season, beaches are replenished by sediment from the local rivers and long-shore current.

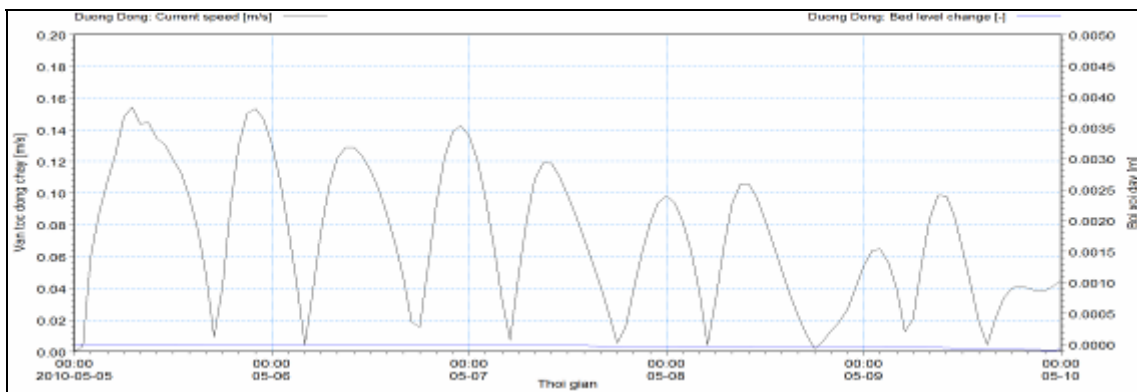
Figure 10. Relation between wav-induced and rate of bed level change in the summer

In the SW monsoon season, high wave damages the beach structure and erodes the beach. During simulation period, rate of bed level change is 0.05 m/month. *Fig. 10* presents the relation between wave-induced and rate of bed level change.

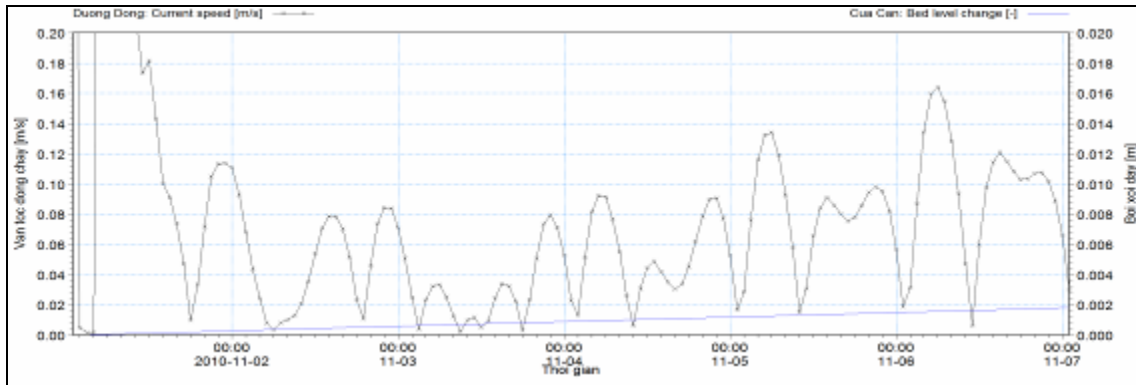
Figure 11. Relation between wav-induced and rate of bed level change in the winter

*Fig. 11* presents the relation between wave-induced and rate of bed level change in the NE monsoon season. Result shows that, rate of bed level change impacted by wave induced is lower than those in the summer (SW monsoon season).

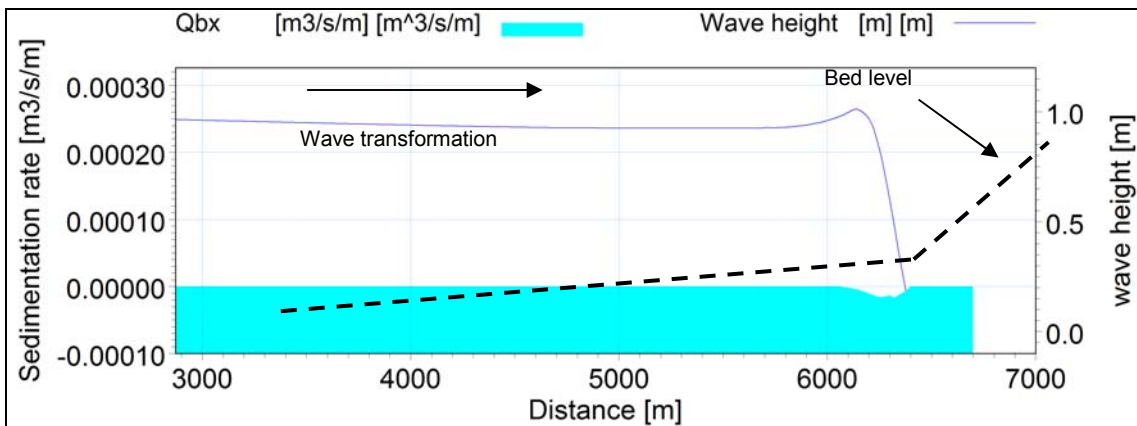
Figure 12. Sedimentation rate at Western beach

*Fig. 12* presents the sedimentation rate at Duong To section. As results, maximum wave energy at the surf zone damaged the bottom

structure. Results show that, at the surf zone, the wave height is maximum, damage the bottom level.

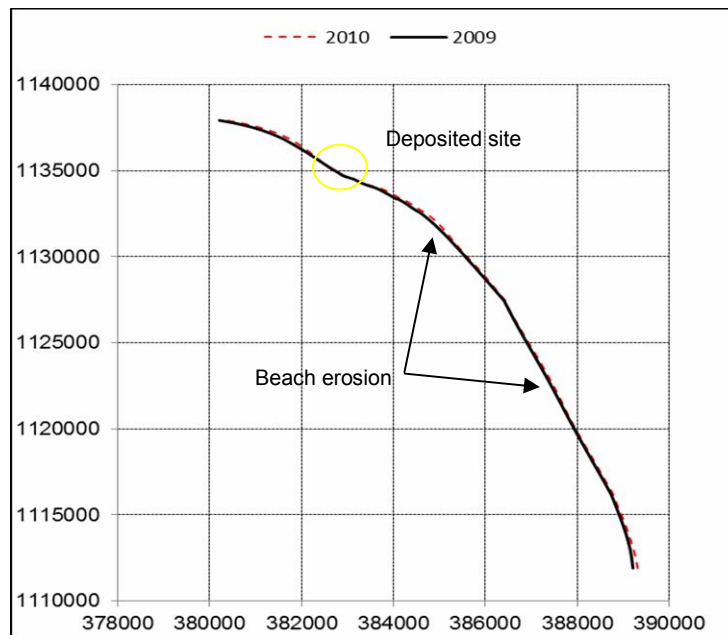
Figure 13. Shore line change simulated in 2010

*Fig. 13* simulates the shore line change under impact by wave and current within one year. Result show that, erosion occurs at the Duong Dong and Duong To beach. Besides, at the Cuu Can river estuary, beach is deposited.

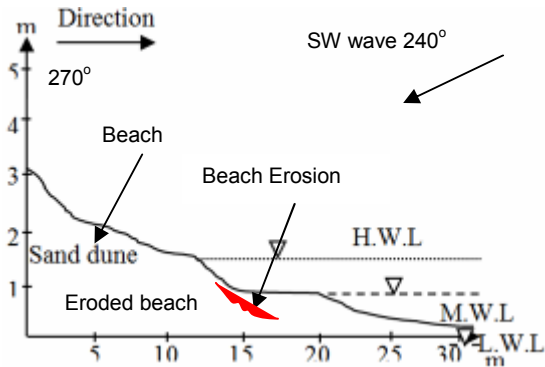
Figure 14. Beach erosion in the summer

Based on field investigation and simulation results, beach erosion at western beach is mainly caused by the impact of wave affected by monsoon. In the summer, SW monsoon is

dominant with high wind, generates high wave and damage the beach. Besides, in the winter, beach is deposited. Fig. 14 and Fig. 15 draw the conceivable beach erosion mechanism at Western beach in the summer and the winter [2, 4].
