## MANGROVE FOREST DEGRADATION AND SHORELINE EROSION IN THE MEKONG DELTA: A CASE STUDY FROM BEN TRE PROVINCE

**Abstract.** Viet Nam's coastline faces many natural and human-induced threats, such as erosion, floods, sea-level changes, pollution and saltwater intrusion. Low lying deltas, such as the Mekong Delta and the Red River Delta of Viet Nam are frequently subjected to such threats. The present study investigated the degradation of mangrove forests and changes in shoreline along the coast of Ben Tre. For this purpose, we used spectral indices, such as the normalized difference vegetation index (NDVI) for mapping mangrove vegetation and the normalized difference water index (NDWI) for estimating shoreline changes. The possibilities, advantages and limitations of coastal vegetation, such as mangroves, casuarina and pandanus, as a bioshield for shoreline protection in Ben Tre coast of the Vietnamese Mekong Delta (VMD) were also discussed. The results show that coastal areas covered with newly planted mangroves showed reduced or no erosion. Currently, several hard structures have been used for short-term protection from coastal erosion in Ben Tre. For long-term coastal protection,

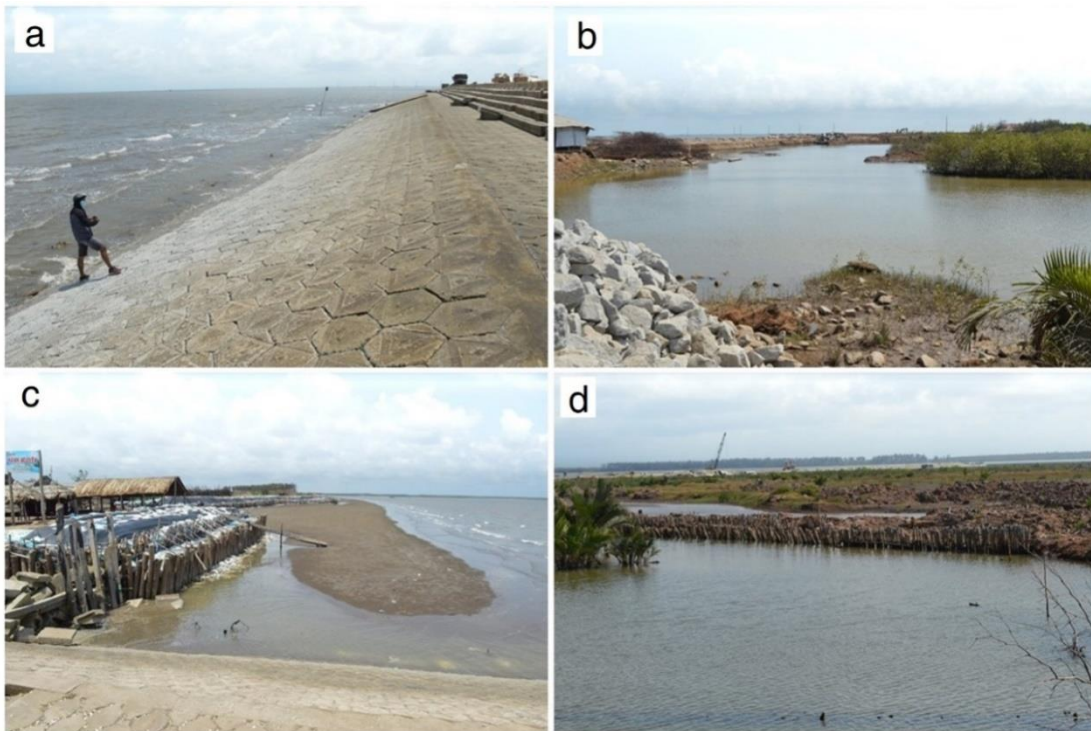
Figure 3. Hard structures (a-b) and breakwaters (c-d) used for coastal protection in Ben Tre.

The same study mentioned that the expansion of shrimp ponds that require brackish water is one of the reasons behind soil salinity changes in Ben Tre. However, shrimp farming is one of the key economic resources in the province and, hence, complete disruption of shrimp farming may have severe negative impacts on the regional economy. With this view, alternative environmental management strategies need to be implemented for the sustainable development of the coastal areas of Ben Tre. Shoreline erosion, sea-level rise and tides from the East Sea are other coastal environmental threats affecting the population in the coastal region of Ben Tre [10]. It was reported that a 1 m rise in the sea level height may cause floods in more than half of the land area in Ben Tre [11]. Veetil *et al.* [3] reported that the sea level heights along the Ben Tre coast fluctuated under El Nino conditions, which also influences saltwater intrusion into river systems in the region. Coastal erosion in Ben Tre has been, so far, protected using hard structures and breakwaters using wooden piles (Figure 3).

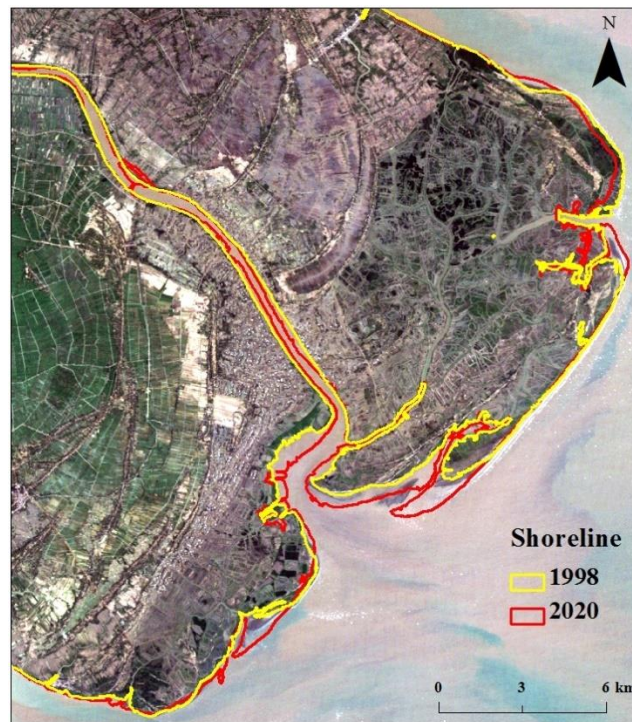
Figure 6. Shoreline changes in Ba Tri and Binh Dai (1998-2020). Shoreline polygons superimposed on Landsat image taken in 1998.

Shoreline changes observed along the coast of Binh Dai and Ba Tri districts showed some interesting facts. It is seen that, despite erosion reported from the southern coast of Ben Tre, coastal areas surrounding the Ba Lai river mouth showed accretion (Figure 6). It has to be noted that a dam has built in the Ba Lai river in 2002 and this would have resulted in reduced sediment
